MEMORANDUM

Subject: Monthly Noise Report for Construction Noise Monitors, September 2019

This memorandum presents the results of the construction noise monitoring along the border between West Los Angeles College and several communities to the northwest of the campus, including Raintree, Tara Hill, Lakeside Village, and Lakeside Villas. There are currently three monitors installed to monitor construction-related truck and equipment noise, with plans to install an additional two monitors as soon as appropriate sites can be secured. Each monitor is an independent station consisting of a microphone, sound level meter, and assorted ancillary equipment. The locations of the monitors are shown in Appendix A.

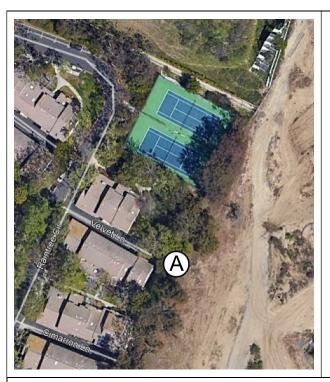
Figure 4: Photographs of Noise Monitor A

Monitor A: Monitor A has not yet been installed.

Monitor A is located near the northeast corner of the Raintree complex, south of the tennis courts and close to the property fence on the eastern edge of the Raintree complex. The microphone head is approximately level with the lower stories of the Raintree residences. Prior to construction activity, the primary noise sources in the area are local traffic, airplanes, residential activity, landscaping equipment and lawnmowers, and distant traffic noise from Interstate 405.

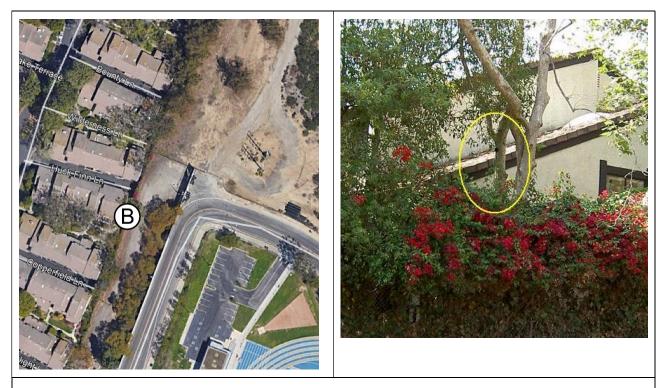
Figure 5: Photographs of Noise Monitor B

Monitor B: The microphone at Monitor B is no longer serviceable due to extreme old age. The monitor will be returned to service when a replacement has been obtained.

Monitor B is located hanging from a tree at a height of approximately 15 feet above ground level near the residence at 5111 Wilderness Lane. The microphone head is approximately level with the second story of the nearby Raintree residences. The monitor is located about 65 feet away from Freshman Drive and about 140 feet away from where the road turns right and becomes Sophomore Drive. Prior to construction activity, the primary noise source in the area was local traffic on Freshman Drive and Sophomore Drive.

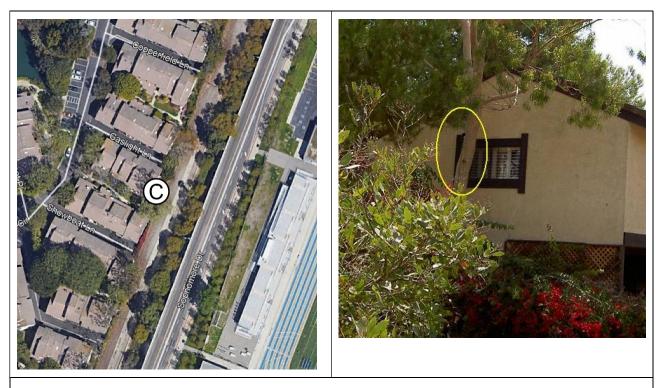
Figure 6: Photographs of Noise Monitor C

Monitor C is located hanging from a tree at a height of approximately 30 feet above ground level near the residence at 5111 Gaslight Lane. The microphone head is approximately level with the second story of the nearby Raintree residences. The monitor is located about 75 feet away from Freshman Drive. Prior to construction activity, the primary noise source in the area was local traffic on Freshman Drive.

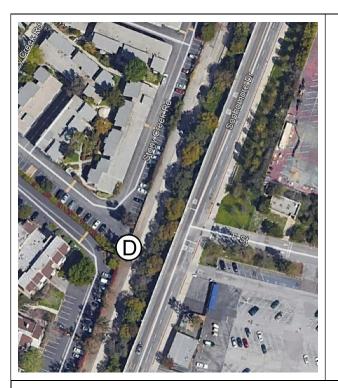
Figure 8: Photographs of Noise Monitor D

Monitor D: Monitor D was installed on June 5. The monitor has yet to maintain power cycling through the month.

Monitor D is located at the southeast corner of the Tara Hill complex. The microphone head is approximately level with the upper stories of the Tara Hill residences. The monitor is located about 80 feet away from Freshman Drive. Prior to construction activity, the primary noise source in the area was local traffic on Freshman Drive.
