## MEMORANDUM

**Subject:** Monthly Noise Report for Construction Noise Monitors, March 2020

This memorandum presents the results of the construction noise monitoring along the border between West Los Angeles College and several communities to the northwest of the campus, including Raintree, Tara Hill, Lakeside Village, and Lakeside Villas. There are currently three monitors installed to monitor construction-related truck and equipment noise, with plans to install an additional two monitors as soon as appropriate sites can be secured. Each monitor is an independent station consisting of a microphone, sound level meter, and assorted ancillary equipment. The locations of the monitors are shown in Appendix A.

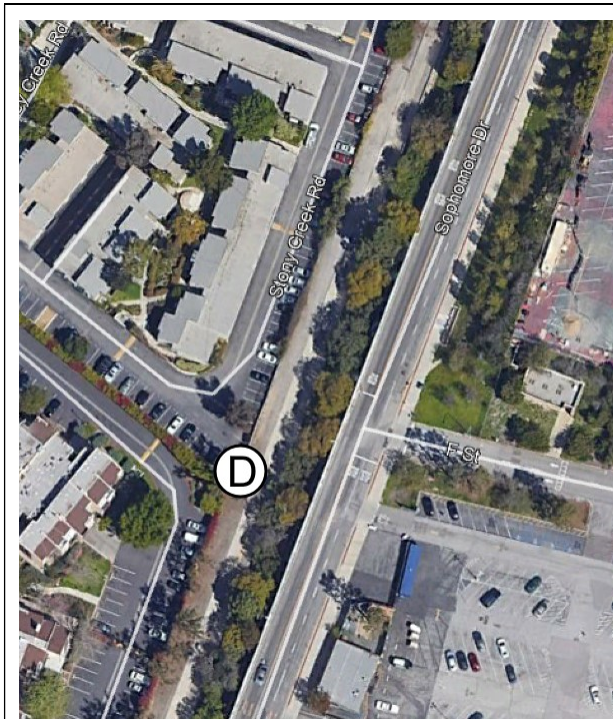
**Figure 8: Photographs of Noise Monitor D**

**Monitor D:** Monitor D was installed on June 5. The monitor has yet to maintain power cycling through the month.

Monitor D is located at the southeast corner of the Tara Hill complex. The microphone head is approximately level with the upper stories of the Tara Hill residences. The monitor is located about 80 feet away from Freshman Drive. Prior to construction activity, the primary noise source in the area was local traffic on Freshman Drive.
