MEMORANDUM

Subject: Monthly Noise Report for Construction Noise Monitors, October 2019

This memorandum presents the results of the construction noise monitoring along the border between West Los Angeles College and several communities to the northwest of the campus, including Raintree, Tara Hill, Lakeside Village, and Lakeside Villas. There are currently three monitors installed to monitor construction-related truck and equipment noise, with plans to install an additional two monitors as soon as appropriate sites can be secured. Each monitor is an independent station consisting of a microphone, sound level meter, and assorted ancillary equipment. The locations of the monitors are shown in Appendix A.

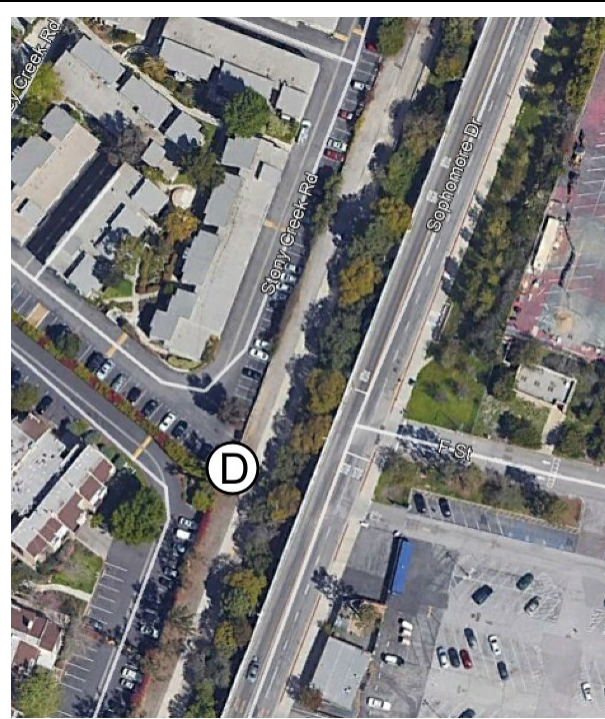
Figure 8: Photographs of Noise Monitor D

Monitor D: Monitor D was installed on June 5. The monitor has yet to maintain power cycling through the month.

Monitor D is located at the southeast corner of the Tara Hill complex. The microphone head is approximately level with the upper stories of the Tara Hill residences. The monitor is located about 80 feet away from Freshman Drive. Prior to construction activity, the primary noise source in the area was local traffic on Freshman Drive.
