### **MEMORANDUM**

**BuildLACCD**

Subject: Monthly Noise Report for Construction Noise Monitors, September 2021

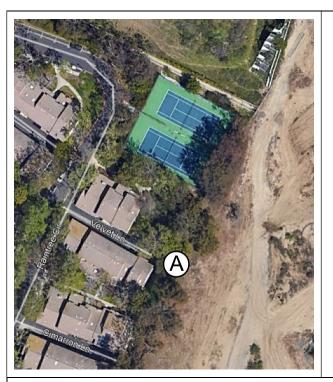
Figure 3: Photographs of Noise Monitor A

Monitor A is located near the northeast corner of the Raintree complex, south of the tennis courts and close to the property fence on the eastern edge of the Raintree complex. The microphone head is approximately level with the lower stories of the Raintree residences. Prior to construction activity, the primary noise sources in the area are local traffic, airplanes, residential activity, landscaping equipment and lawnmowers, and distant traffic noise from Interstate 405.

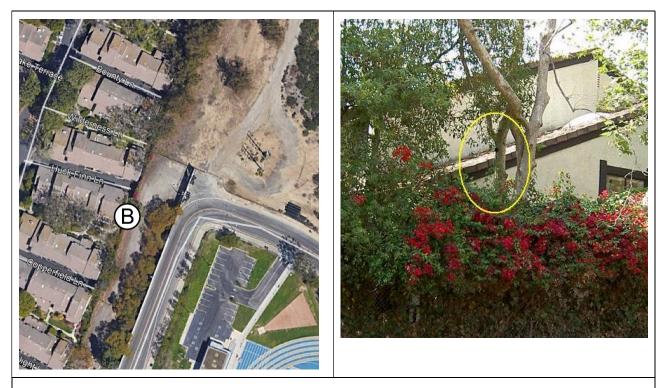
Figure 4: Photographs of Noise Monitor B

**Monitor B:** The microphone at Monitor B is no longer serviceable due to extreme old age. The monitor will be returned to service when a replacement has been obtained.

Monitor B is located hanging from a tree at a height of approximately 15 feet above ground level near the residence at 5111 Wilderness Lane. The microphone head is approximately level with the second story of the nearby Raintree residences. The monitor is located about 65 feet away from Freshman Drive and about 140 feet away from where the road turns right and becomes Sophomore Drive. Prior to construction activity, the primary noise source in the area was local traffic on Freshman Drive and Sophomore Drive.

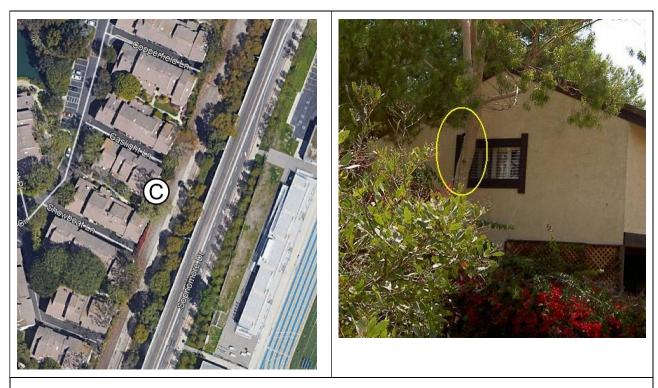
Figure 5: Photographs of Noise Monitor C

Monitor C is located hanging from a tree at a height of approximately 30 feet above ground level near the residence at 5111 Gaslight Lane. The microphone head is approximately level with the second story of the nearby Raintree residences. The monitor is located about 75 feet away from Freshman Drive. Prior to construction activity, the primary noise source in the area was local traffic on Freshman Drive.

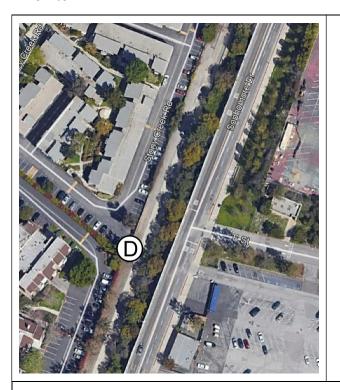
Figure 7: Photographs of Noise Monitor D

**Monitor D:** Monitor D was installed on June 5. The monitor has yet to maintain power cycling through the month.

Monitor D is located at the southeast corner of the Tara Hill complex. The microphone head is approximately level with the upper stories of the Tara Hill residences. The monitor is located about 80 feet away from Freshman Drive. Prior to construction activity, the primary noise source in the area was local traffic on Freshman Drive.
