MEMORANDUM

Subject: Monthly Noise Report for Raintree Noise Monitors, June 2017

This memorandum presents the results of the noise monitoring at the Raintree residential complex near the West Los Angeles College (WLAC) campus. There are four monitors positioned near the property lines of the Raintree complex to monitor construction-related truck and equipment noise from the north end of the campus as well as from College Boulevard which runs from the northwest corner of campus to Jefferson Boulevard. Each monitor is an independent station consisting of a microphone, sound level meter, cell phone modem, and assorted ancillary equipment. The locations of the monitors are shown in Appendix A.

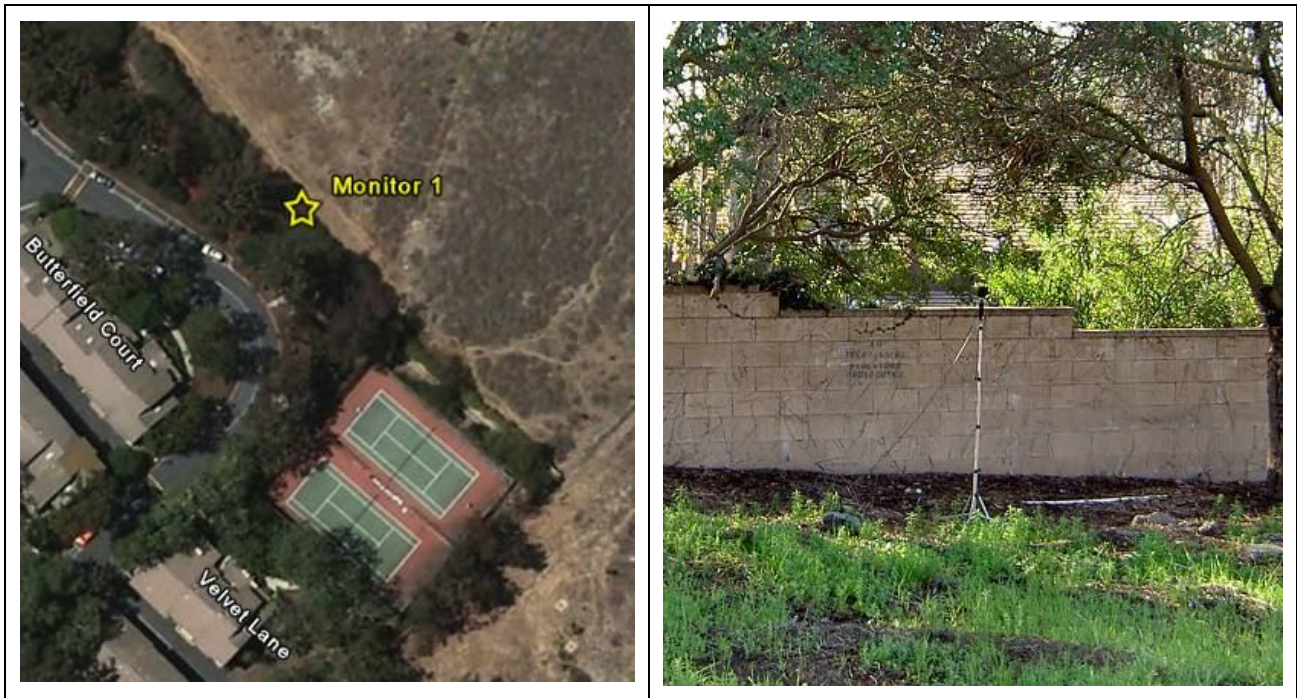
Figure 3: Photographs of Noise Monitor 1

Monitor 1: At some point during the month of May the monitor was stolen. The monitor has not yet been replaced.

Monitor 1 is located to the northeast of the Raintree complex, near the property wall that separates Raintree Circle from where the haul road cuts through to Jefferson Boulevard. Due to topography, the microphone head is approximately level with the upper stories of the Raintree residences. The monitor is located about 250 feet away from the closest point on the haul road. Prior to construction activity, the primary noise sources in this area were residential activity, landscaping equipment and lawnmowers, airplanes, athletic activity on the nearby tennis courts, and traffic noise from Jefferson Boulevard.

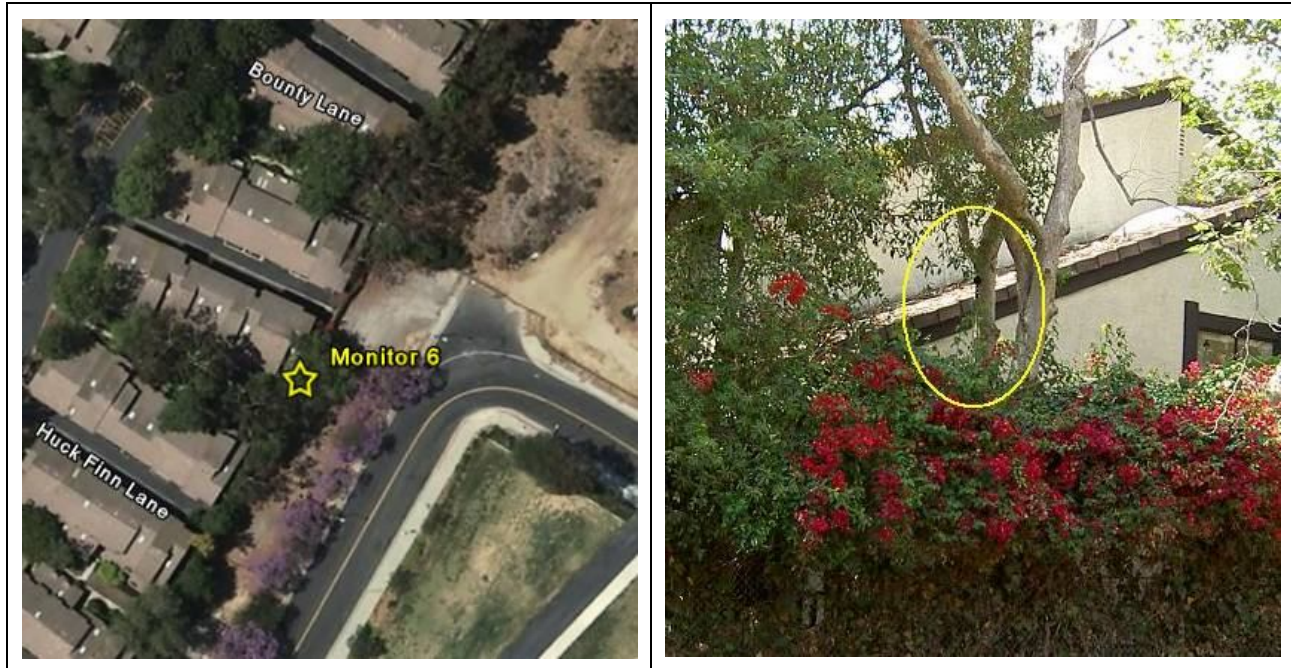
Figure 5: Photographs of Noise Monitor 6

Monitor 6: Monitor 6 was shut down due to equipment issues.

Monitor 6 is located hanging from a tree at a height of approximately 15 feet above ground level near the residence at 5111 Wilderness Lane. The microphone head is approximately level with the second story of the nearby Raintree residences. The monitor is located about 65 feet away from Freshman Drive and about 140 feet away from where the haul road diverges from Sophomore Drive. Prior to construction activity, the primary noise source in the area was local traffic on Freshman Drive and Sophomore Drive.

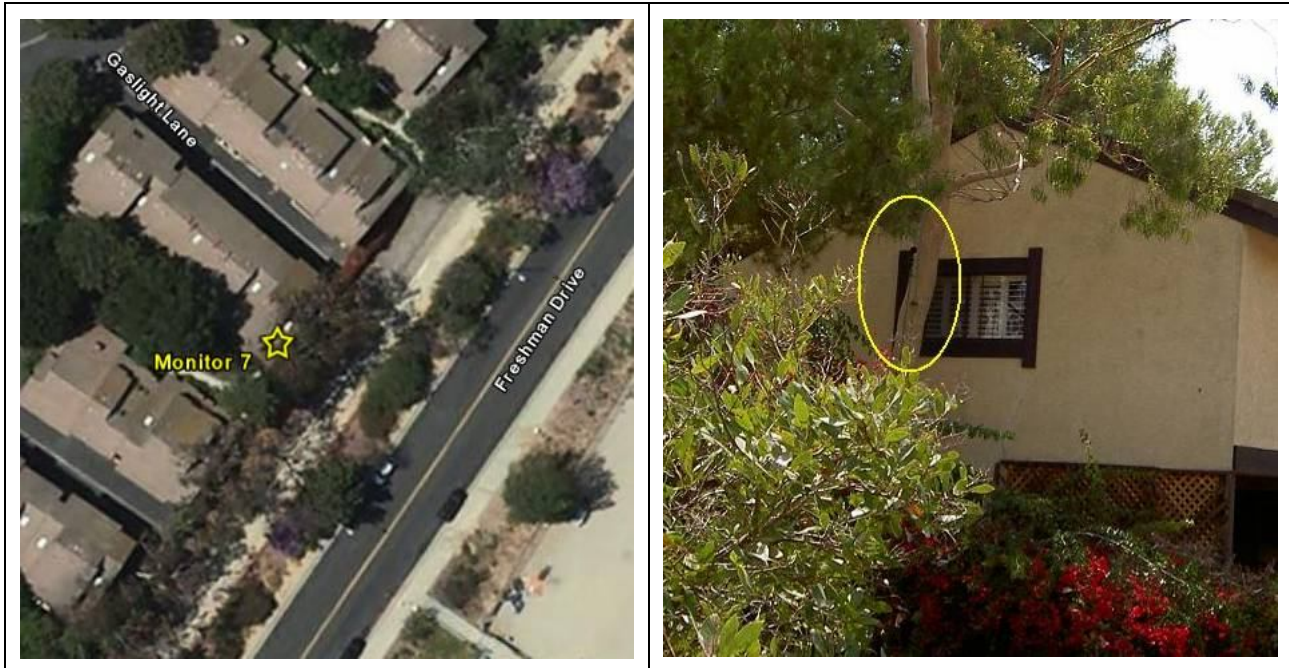
Figure 6: Photographs of Noise Monitor 7

Monitor 7 is located hanging from a tree at a height of approximately 30 feet above ground level near the residence at 5111 Gaslight Lane. The microphone head is approximately level with the second story of the nearby Raintree residences. The monitor is located about 75 feet away from Freshman Drive and about 500 feet away from where the haul road diverges from Sophomore Drive. Prior to construction activity, the primary noise source in the area was local traffic on Freshman Drive.
